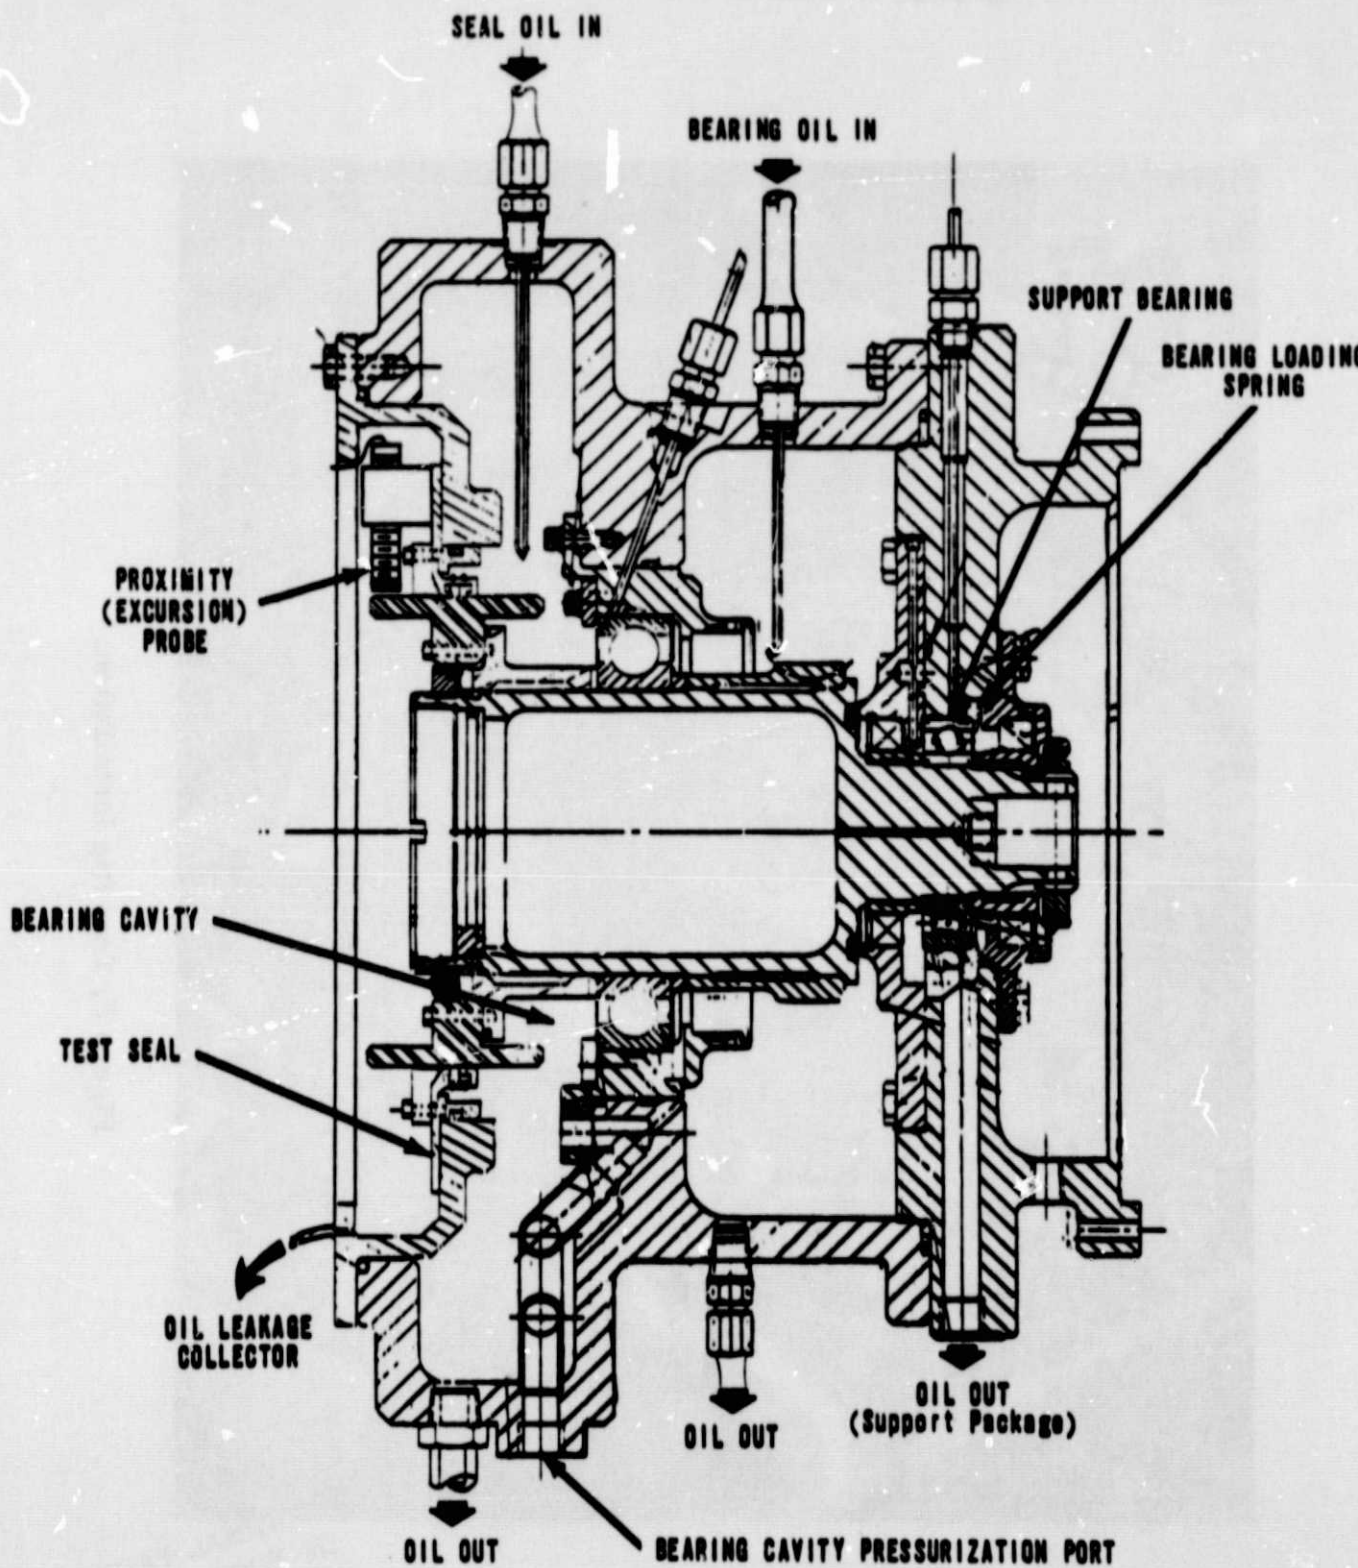
Figure 1. Test Rig.

The test vehicle was the T55-L-7 engine No. 2 position seal test rig (Figure 1), modified to accept the test seal. The test rig prime mover was an 8-inch, 74.57 kw (100 hp), 30,000 rpm steam turbine. An automatic speed control was used to maintain a constant test rig speed. The installation is shown in Figure 2. Lubrication of the test rig and test seal was provided by two separate oil systems as shown in the lubrication schematic (Figure 3). System I serviced the test seal and adjacent bearing while System II serviced the support bearing package.

The test rig was designed to allow varying degrees of seal runner runout to be built into the test rig. The seal runner was not piloted but instead was fastened to an adapter (clamped on the shaft) with bolts. The radial clearance remaining in the bolt holes allowed the runner to be shifted, and the desired runout was achieved. A proximity probe was used to monitor the dynamic shaft runout.

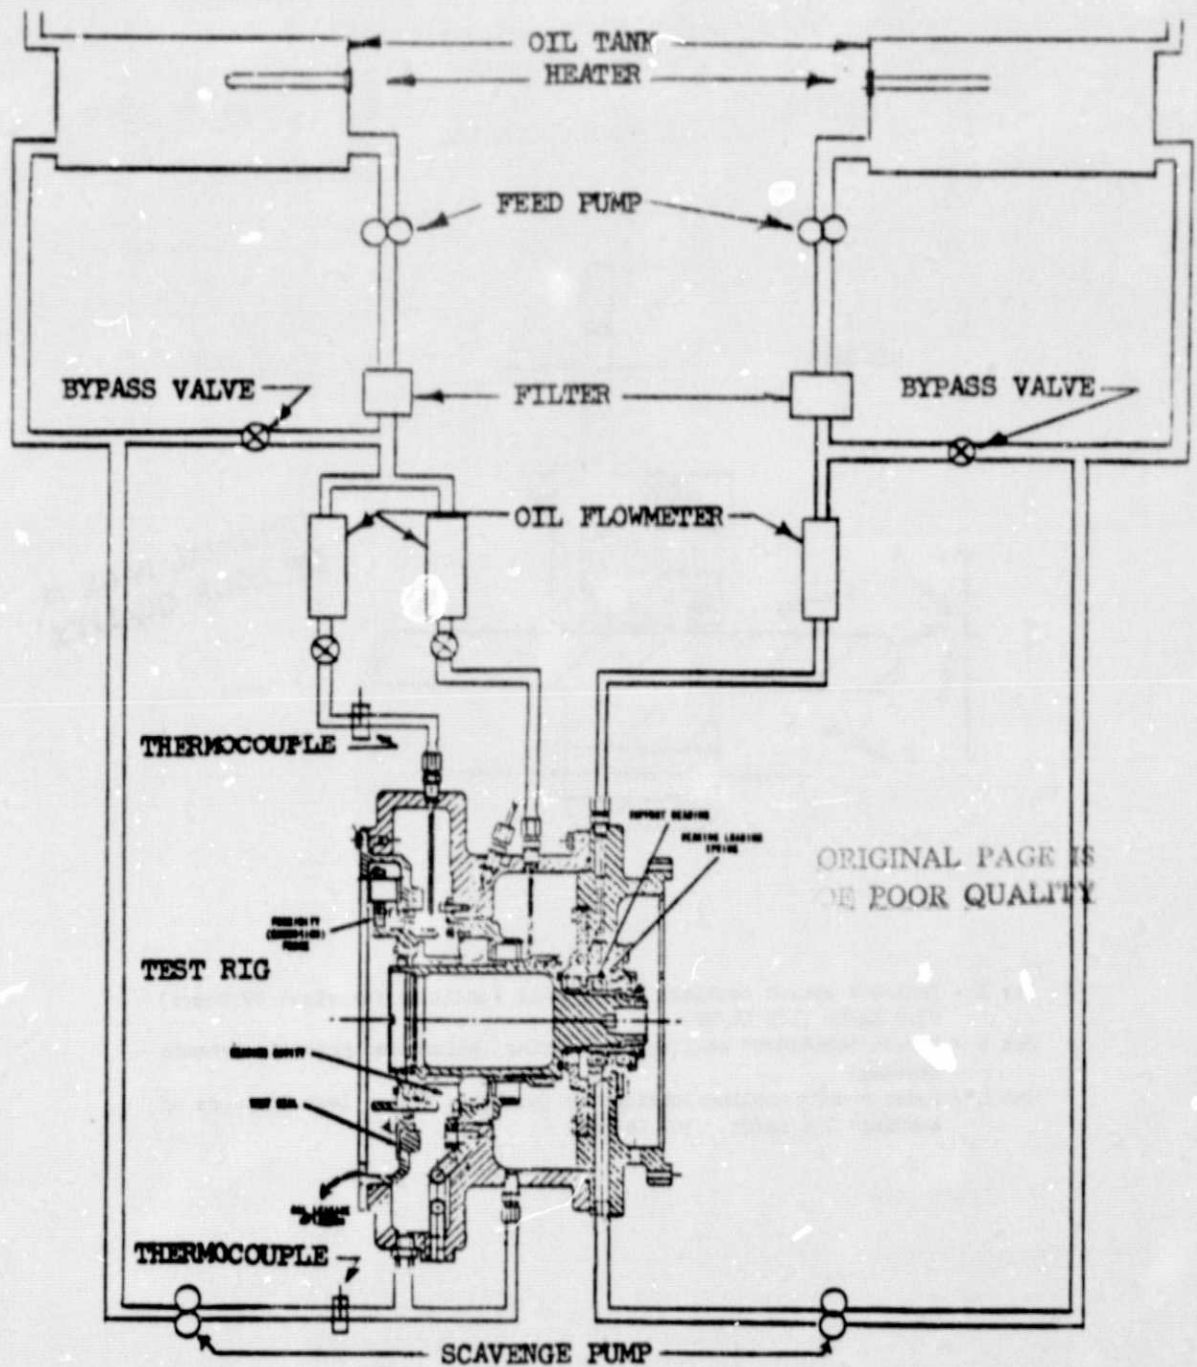
Figure 3. Schematic of the Lubrication System.

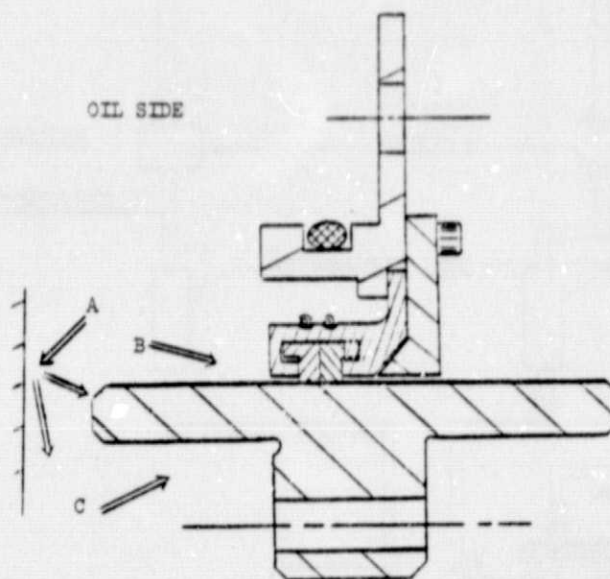
- Jet A - Indirect splash cooling/ lubricating (utilized for first 47 hours)
83.9 Kg/Hr (185 Lb/Hr)
- Jet B - Direct impingement cooling/lubricating (eliminated prior to Dynamic Testing)
- Jet C - Under runner cooling/lubricating (utilized during last 18 hours of testing) 136 Kg/Hr. (300 Lb/Hr)

Figure 4. Location of Seal Oil Jets.

Oil feed temperature for bearing lubrication and seal cooling was maintained at 338 ± 5 K ($150 \pm 10^\circ\text{F}$). This temperature was selected to encourage leakage modes dependent upon higher lubricant viscosity. One direct impingement jet and one indirect impingement jet were used (Figure 4). Bearing lubricating oil flow was maintained at 136 kg/hr (300 lb/hr) throughout the test. Seal cooling flow was initially maintained at 84 kg/hr (185 lb/hr), but subsequently was redirected and increased to 136 kg/hr (300 lb/hr).

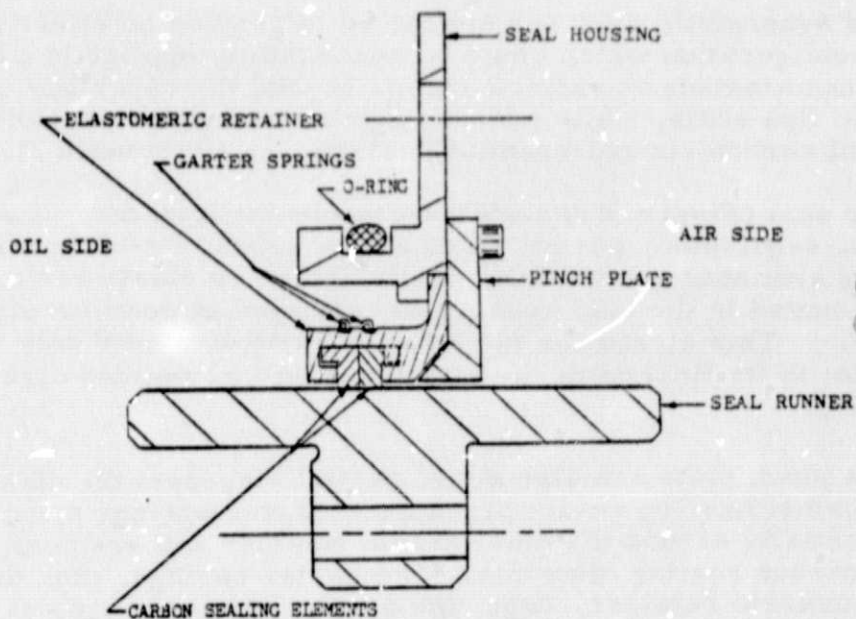
Elastomer - Viton
Housing - 316 Stainless Steel
Sealing Elements - Carbon Graphite
Garter Springs - 300 Series Stainless Steel
Seal Runner - AMS 6382 Steel
Seal Runner Surface - Chrome Plate - .00254 To .00762 CM
(.001 To .003 IN.) Thick
Per AMS 2106

Seal Runner O.D. $13.932 \pm .00127$ CM ($5.481 \pm .0005$ IN.)
Seal Runner Finish - 6 AA
Seal Runner Roundness - .00025 CM (.00010 IN.)
Garter Spring Load - 7.784 N (1.75 Lb) Initially, increased to
11.1 N (2.5 Lb)

Figure 5. Test Seal

The seal (Figure 5) includes six major components. Two interchangeable, segmented, carbon rings act as primary sealing elements. The sealing elements are held and positioned by an elastomeric retainer, which is mounted in the seal housing and clamped in position with a pinch plate. This elastomer mounting scheme was used only for testing convenience; in its final form the elastomer will be molded directly to a steel housing.

The pinch plate can also act to partially support the elastomeric retainer against bearing cavity pressure. Garter springs are mounted circumferentially around the elastomeric retainer and are positioned above the carbon sealing elements. The garter springs, plus the tension of the elastomeric retainer, urge the sealing elements against the seal runner. Sealing is accomplished by maintaining contact between the inside diameter of the sealing element and the runner and between the elastomeric retainer and the outside diameter of the sealing element. Staggering of the segmented rings provides blockage of the potential leakage paths at the segment end gaps. Anti-rotation provision for the carbon rings is made with two lugs machined on the carbon segments, which are accommodated in matching slots molded into the elastomeric retainer.

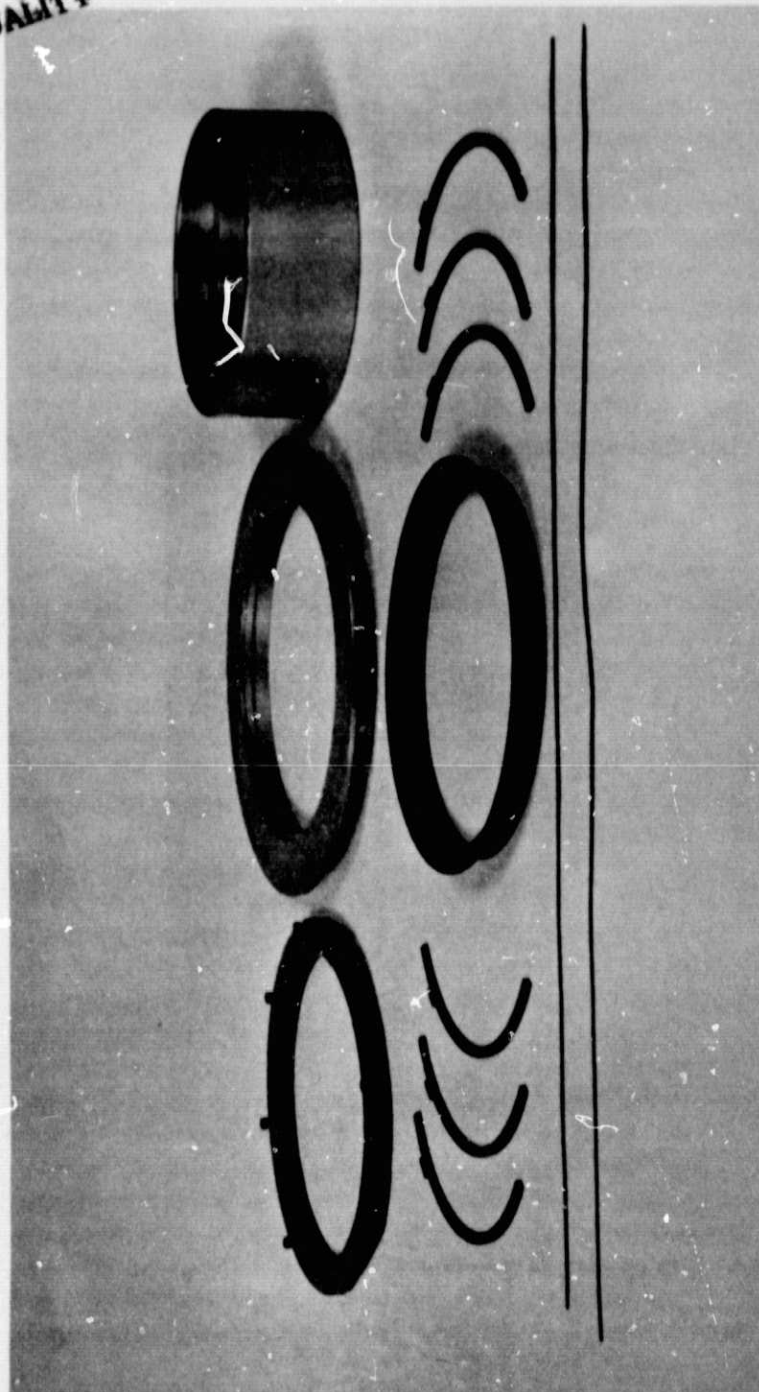
Figure 6. Test Seal Components Before Test.

Prior to the initiation of testing, photographs of test hardware were taken. Figures 6 through 8 show the following; Test seal components prior to test; assembled seal and runner prior to test; a close-up of the seal ID prior to test. A silicone grease, used to aid in assembly of the seal, is visible on the seal bore in Figure 8.

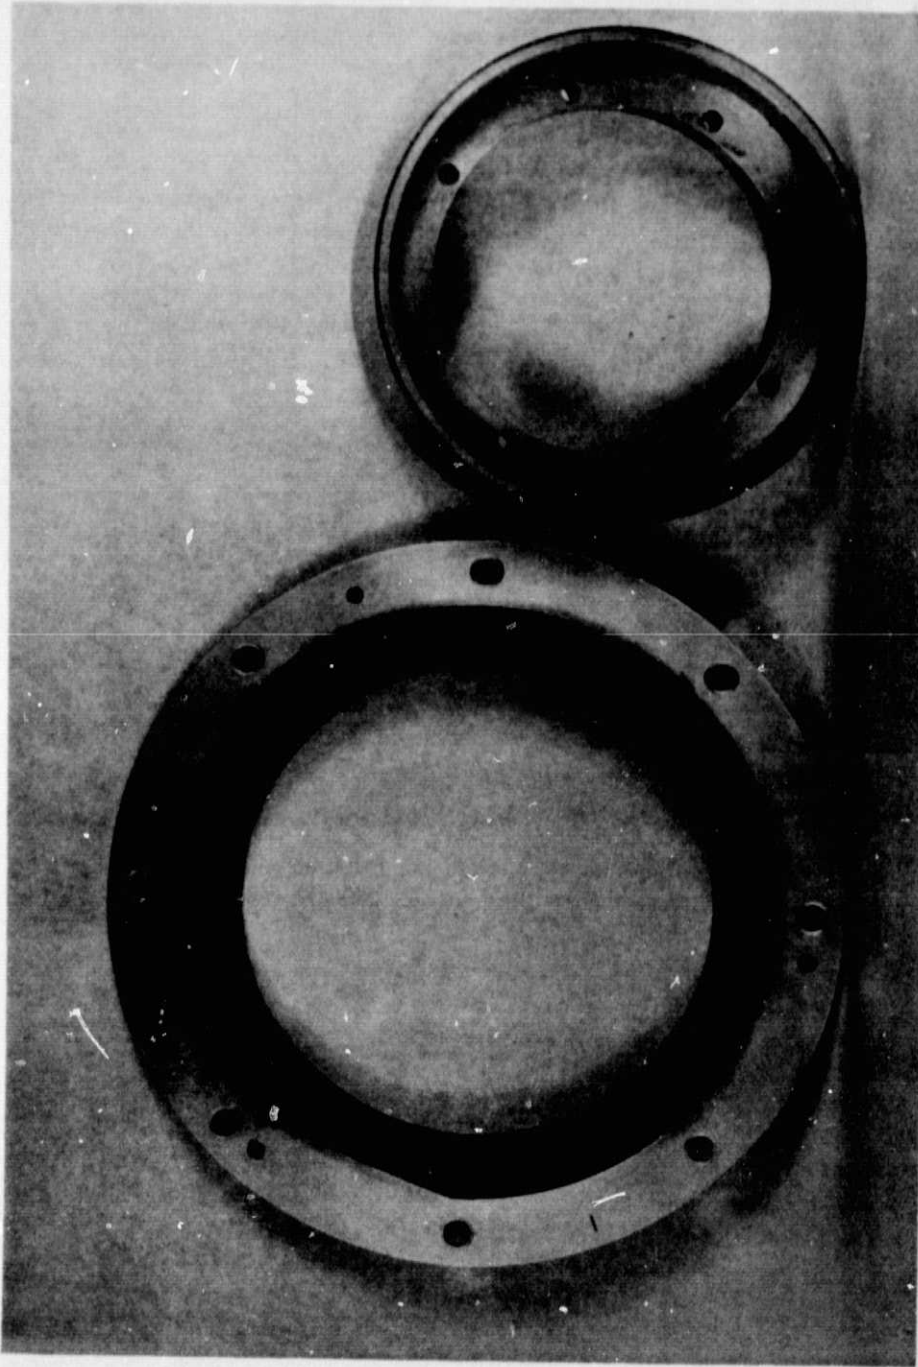
Figure 7. Assembled Seal Before Test.

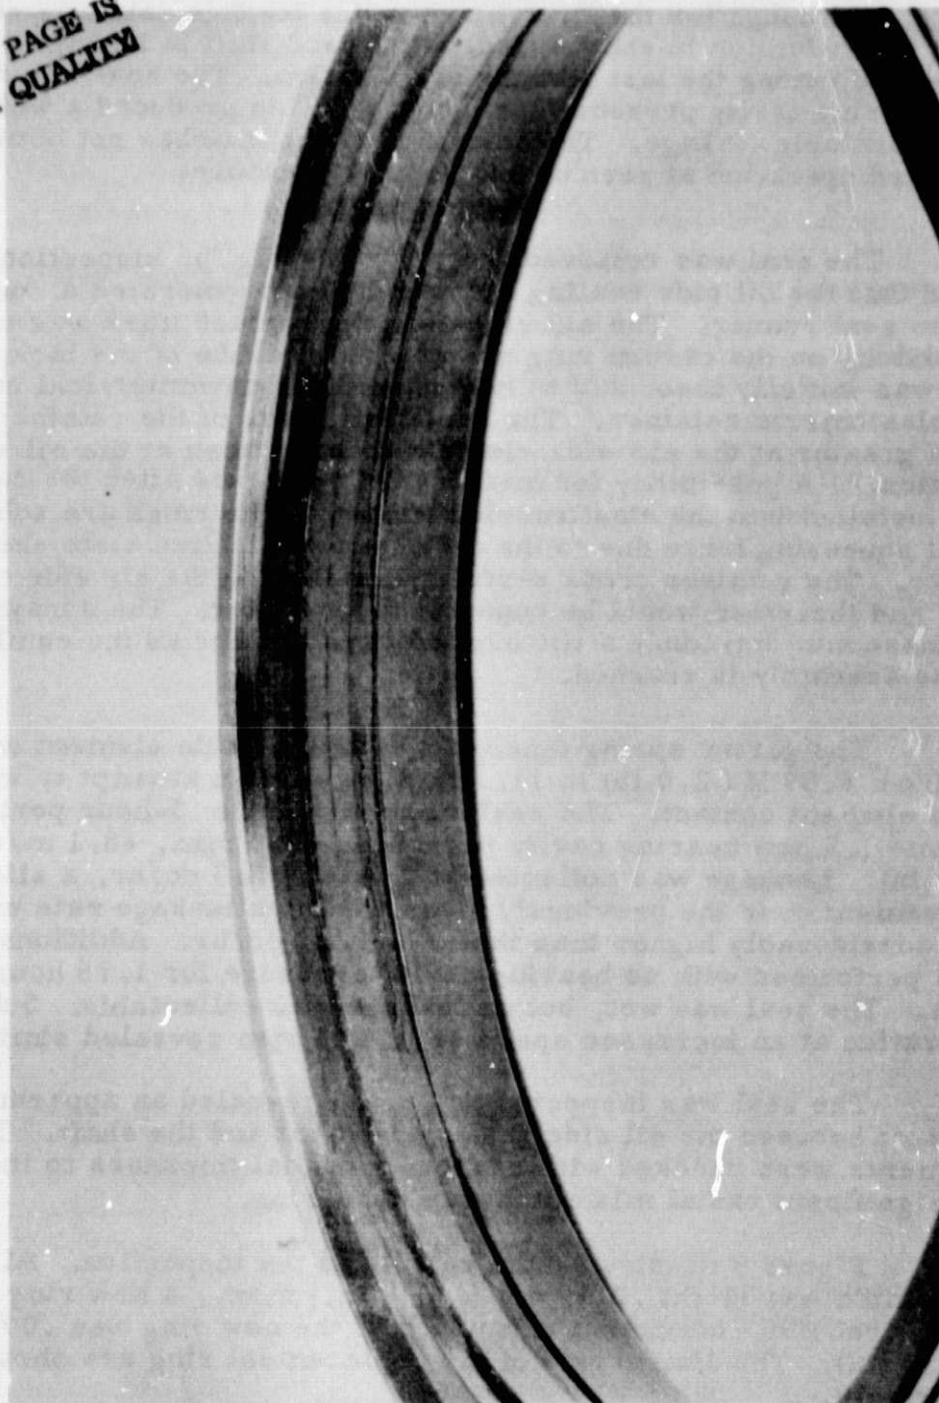
Figure 8. Seal Inside Diameter Before Test.

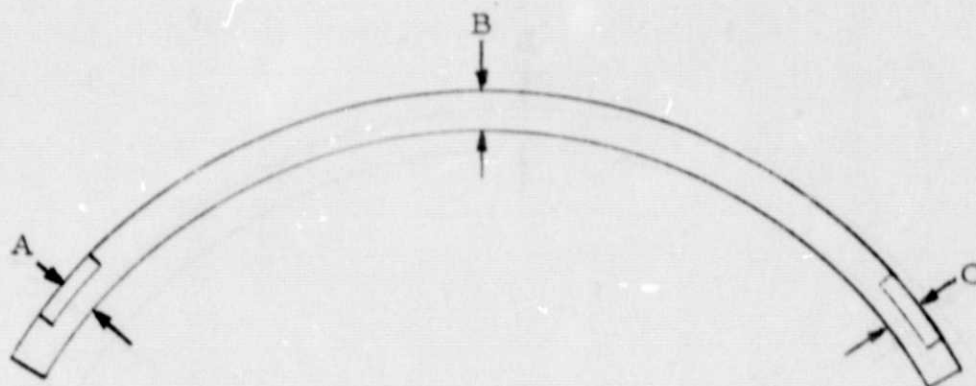
Element A (Air Side)	Location					
	A		B		C	
	cm	(in.)	cm	(in.)	cm	(in.)
Segment 1	.4180	(.1648)	.4148	(.1633)	.4189	(.1649)
Segment 2	.4171	(.1642)	.4171	(.1642)	.4115	(.1620)
Segment 3	.4110	(.1618)*	.4178	(.1645)	.4173	(.1643)

Element C (Oil Side)						
Segment 1	.4120	(.1622)	.4135	(.1628)	.4166	(.1640)
Segment 2	.4229	(.1665)*	.4117	(.1621)	.4209	(.1657)
Segment 3	.4168	(.1641)	.4150	(.1634)	.4166	(.1640)

Figure 9. Carbon Element Radial Dimensions (Disassembly).

Figure 9 illustrates the results of the inspection. Although the mismatch was slight .0119 cm (.0047 in.) max., a new ring was used on the rebuild. Maximum mismatch of the new ring was .0076 cm (.0030 in.). The dimensions of the replacement ring are shown in Figure 10.

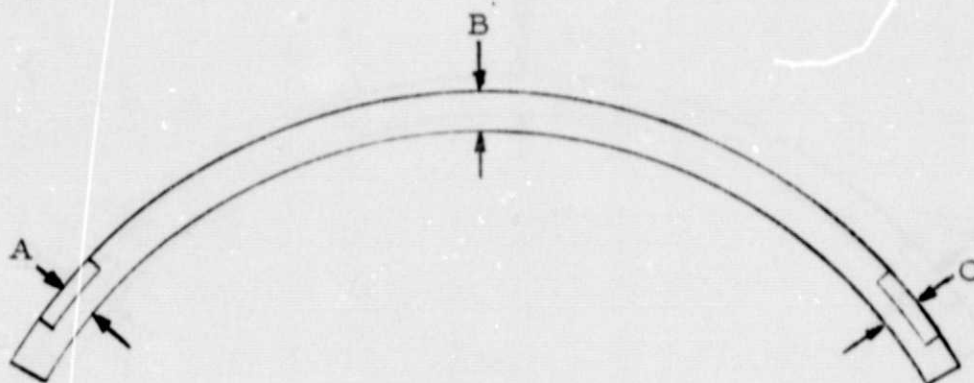
Location					
	A		B		C	
	cm	(in.)	cm	(in.)	cm	(in.)
Segment 1	.4180	(.1648)	.4148	(.1633)	.4189	(.1649)*
Segment 2	.4171	(.1642)	.4171	(.1642)	.4115	(.1620)
Segment 3	.4110	(.1618)	.4178	(.1645)	.4173	(.1643)

Segment 1	.4150	(.1634)	.4148	(.1633)	.4163	(.1639)
Segment 2	.4181	(.1646)	.4112	(.1619)*	.4161	(.1638)
Segment 3	.4168	(.1641)	.4161	(.1638)	.4186	(.1648)

Figure 10. Carbon Element Radial Dimensions (Rebuild)

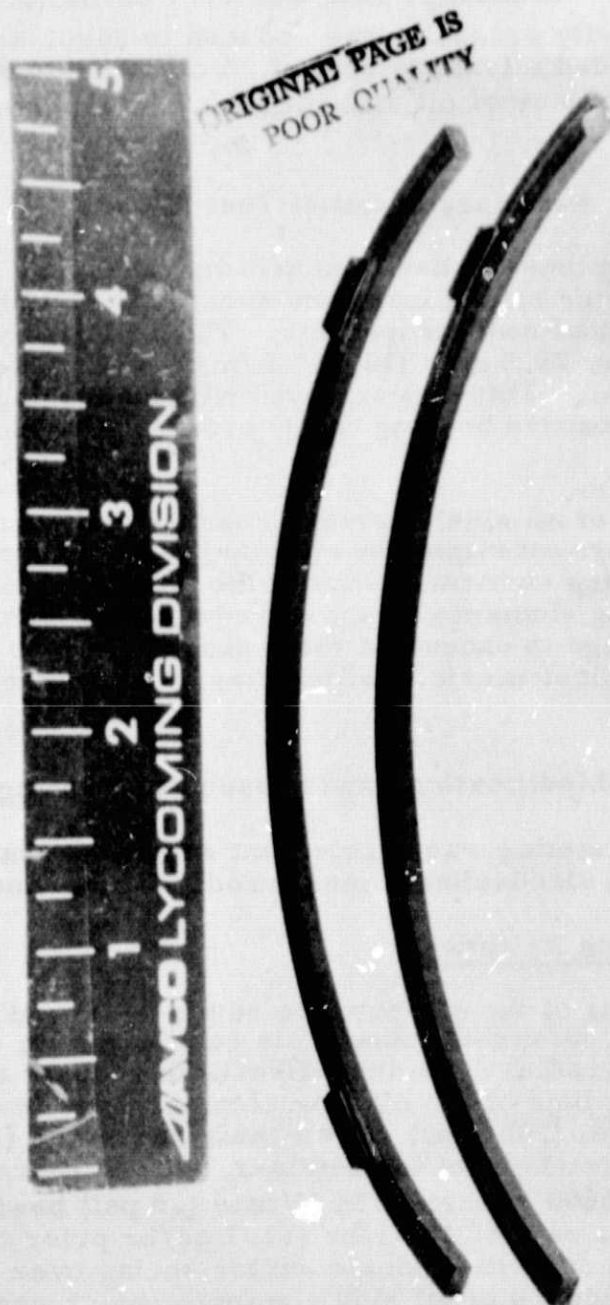
Figure 11. Carbon Element Modifications.

of the sealing element was added to the leading end of each oil side segment (Figure 11). The intent of this modification was to force back into the bearing cavity oil which entered the segment end gaps. Since no improvement in performance had been observed during testing with a single garter spring over the oil side element, both springs were in place during this test. The seal, which was tested at 6600 rpm and $.34 \text{ N/cm}^2$ (.5 psi), exhibited a leakage rate of 30 cc/hr. The seal was retested at no bearing cavity pressure at 6600 rpm for 2.75 hours and revealed a leakage rate of 3.45 cc/hr.

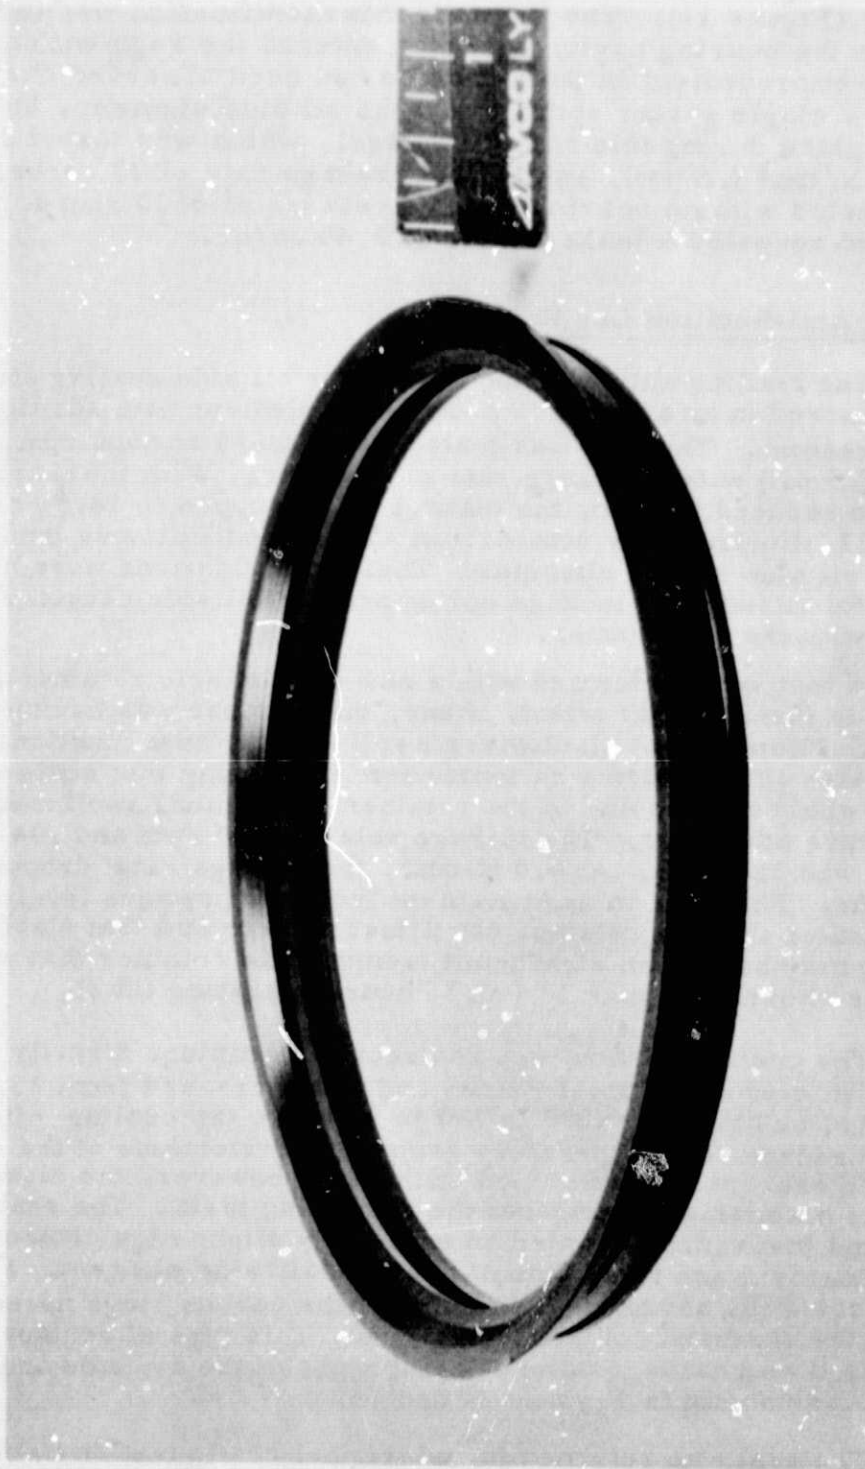
Figure 12. Replaced Retainer .

A test was performed with a new elastomeric retainer in an attempt to identify what effect, if any, the retainer was having on oil leakage. Knowing that elastomers swell slightly as a function of their exposure to oil provided a rationale for suspecting that some of the leakage effect may be due to the retainer. No actual swell measurements were attempted. The leakage rate at 6600 rpm and $.34 \text{ N/cm}^2$ (.5 psi) was 16 cc/hr. At 0.0 N/cm^2 , the leakage rate dropped to 2.3 cc/hr. This was an improvement from the previous levels measured and indicates that the retainer can affect leakage and that elastomeric swelling may have been significant factor. The retainer that was replaced is shown in Figure 12 (43.75 hours operating time).

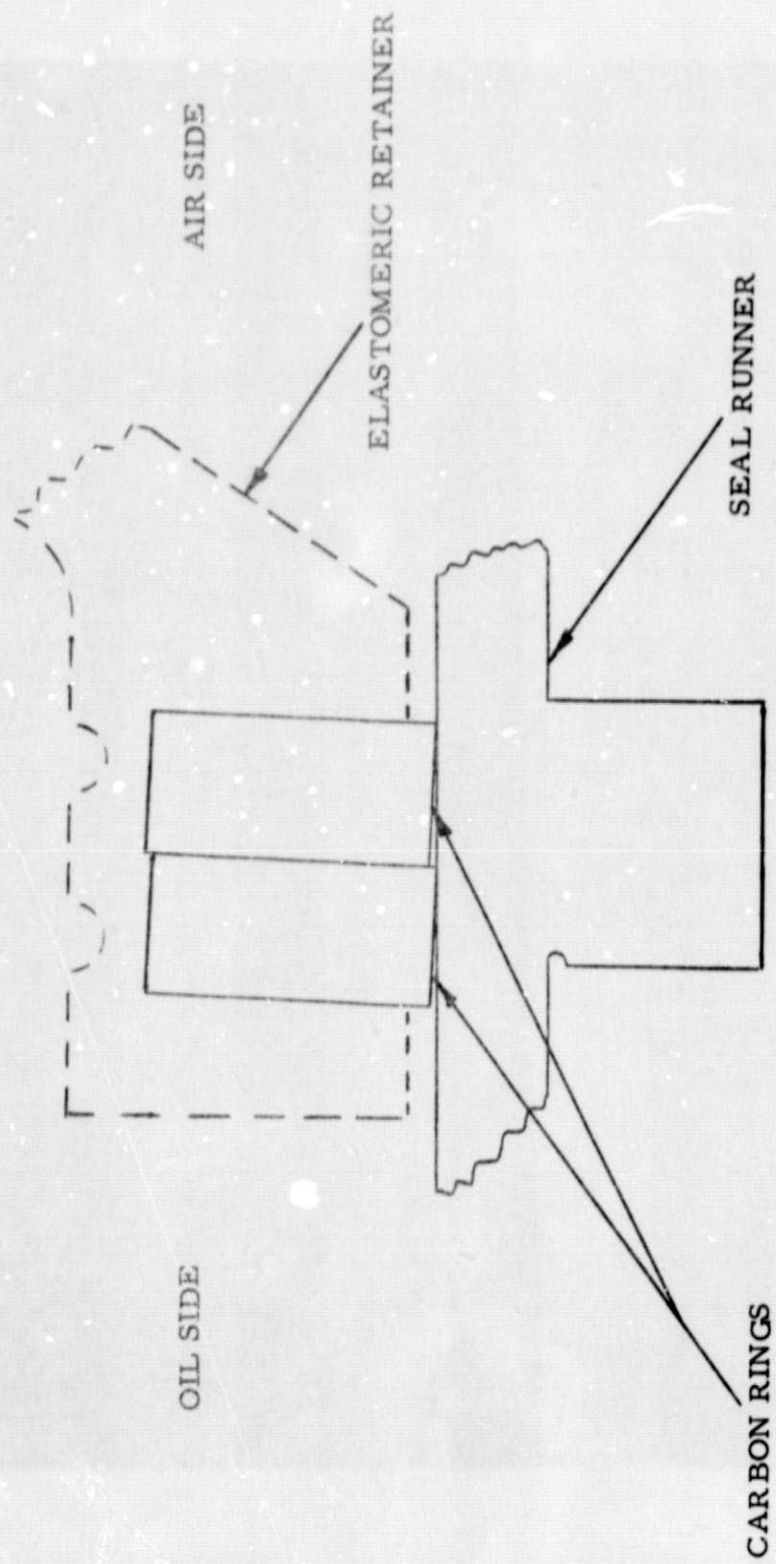
Figure 13. Mispositioned Carbon Rings.

The cooling oil flow was redirected to impinge directly on the inside diameter of the steel runner and was increased from 83.9 kg/hr (185 lb/hr) to 136 kg/hr (300 lb/hr) to increase the cooling effect with the intent to reduce any temperature associated distortions of the seal runner. Measured seal leakage remained unchanged; however, the higher oil flow level was maintained throughout the remaining tests. The seal was removed and inspection revealed an extremely slight edge contact on the oil side element and typical contact on the air side element. Figure 13 illustrates the assumed positioning of the carbon rings necessary to produce the observed contact indications. This type of contact would produce a direct leakage path. Photographs of the air side and oil side elements are shown in Figures 14 and 15.

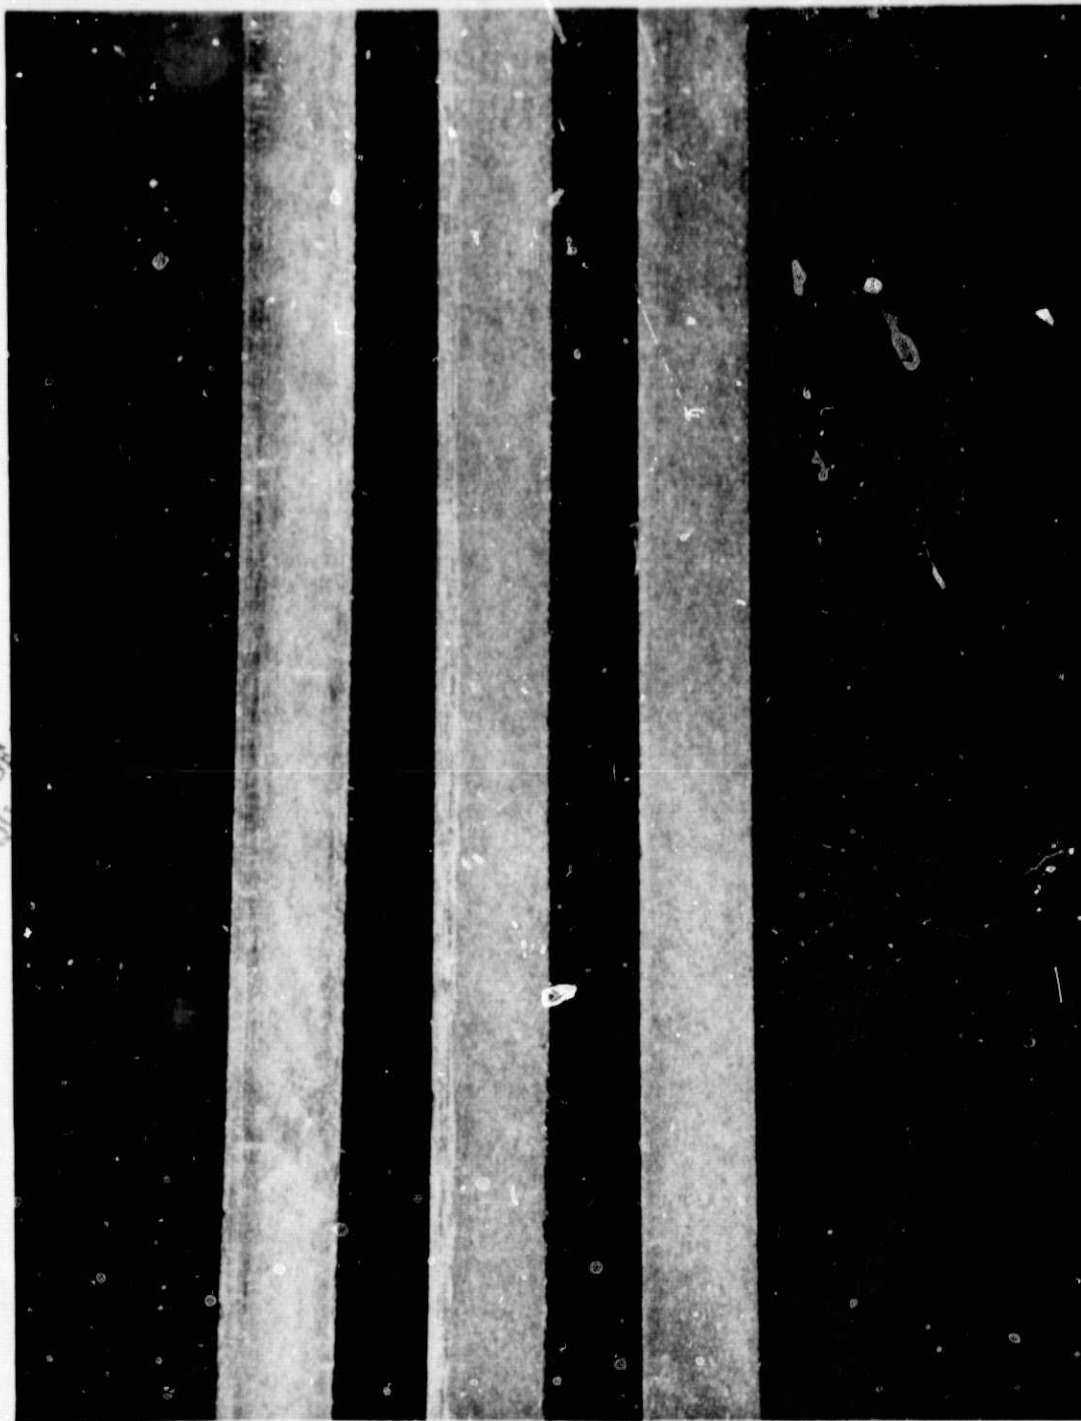
Figure 14. Air Side Elements After Test.

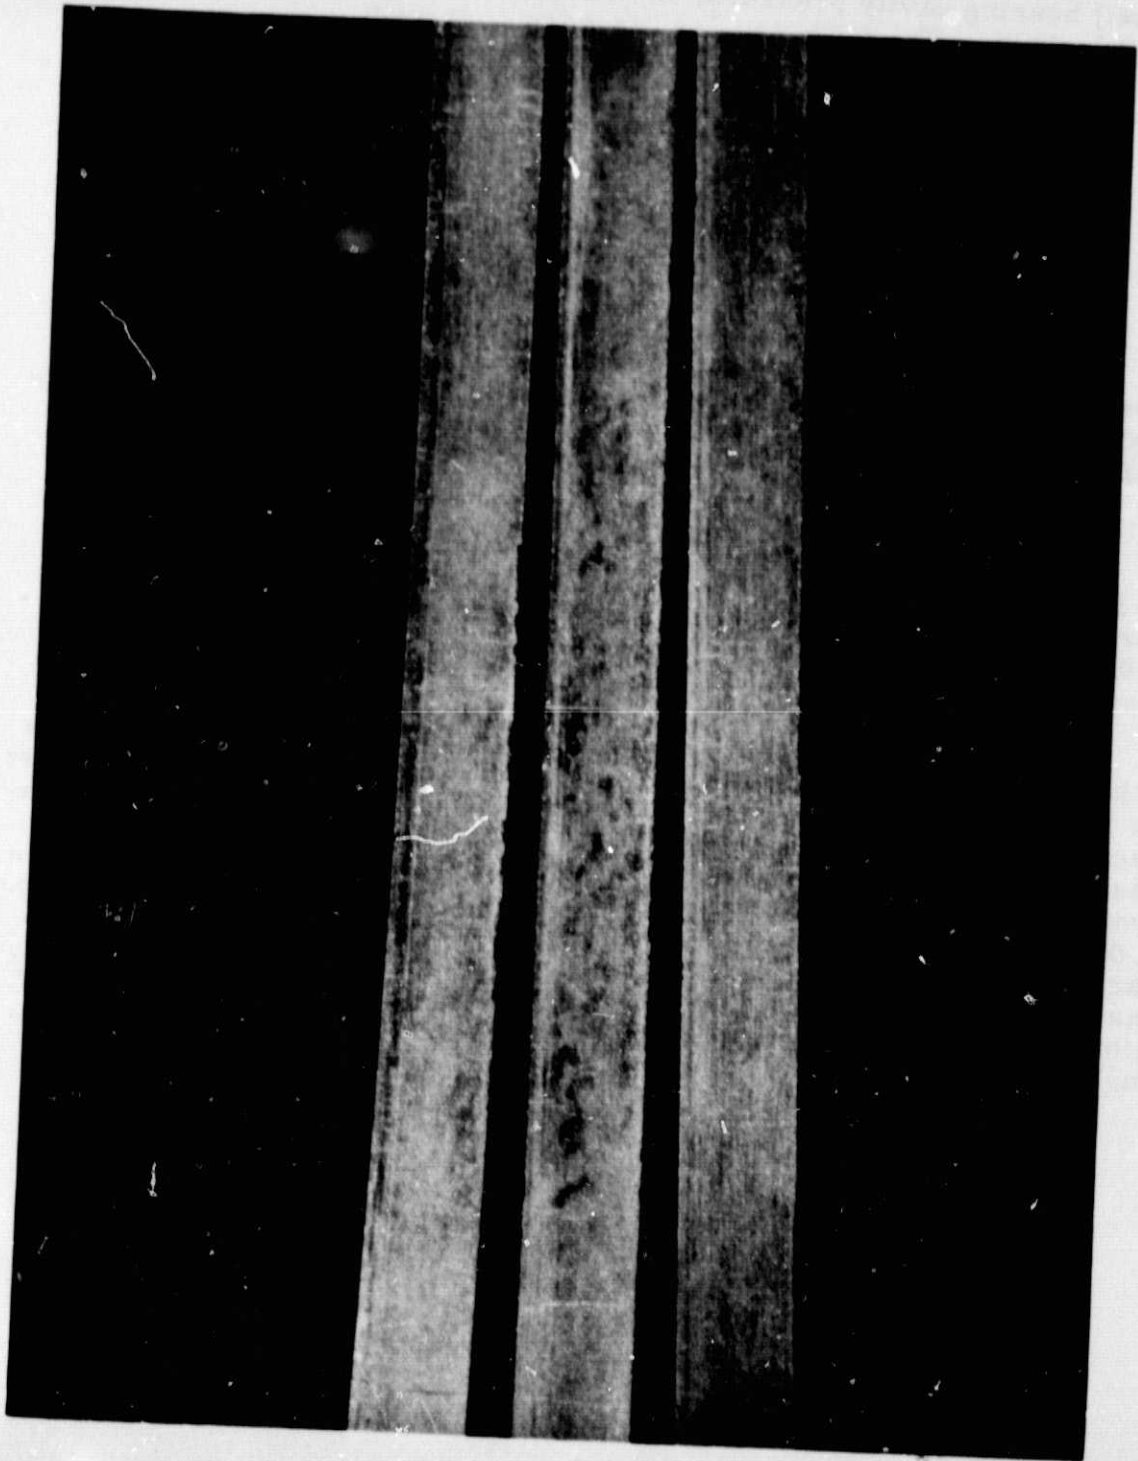
Figure 15. Oil Side Elements After Test
(With Modifications).

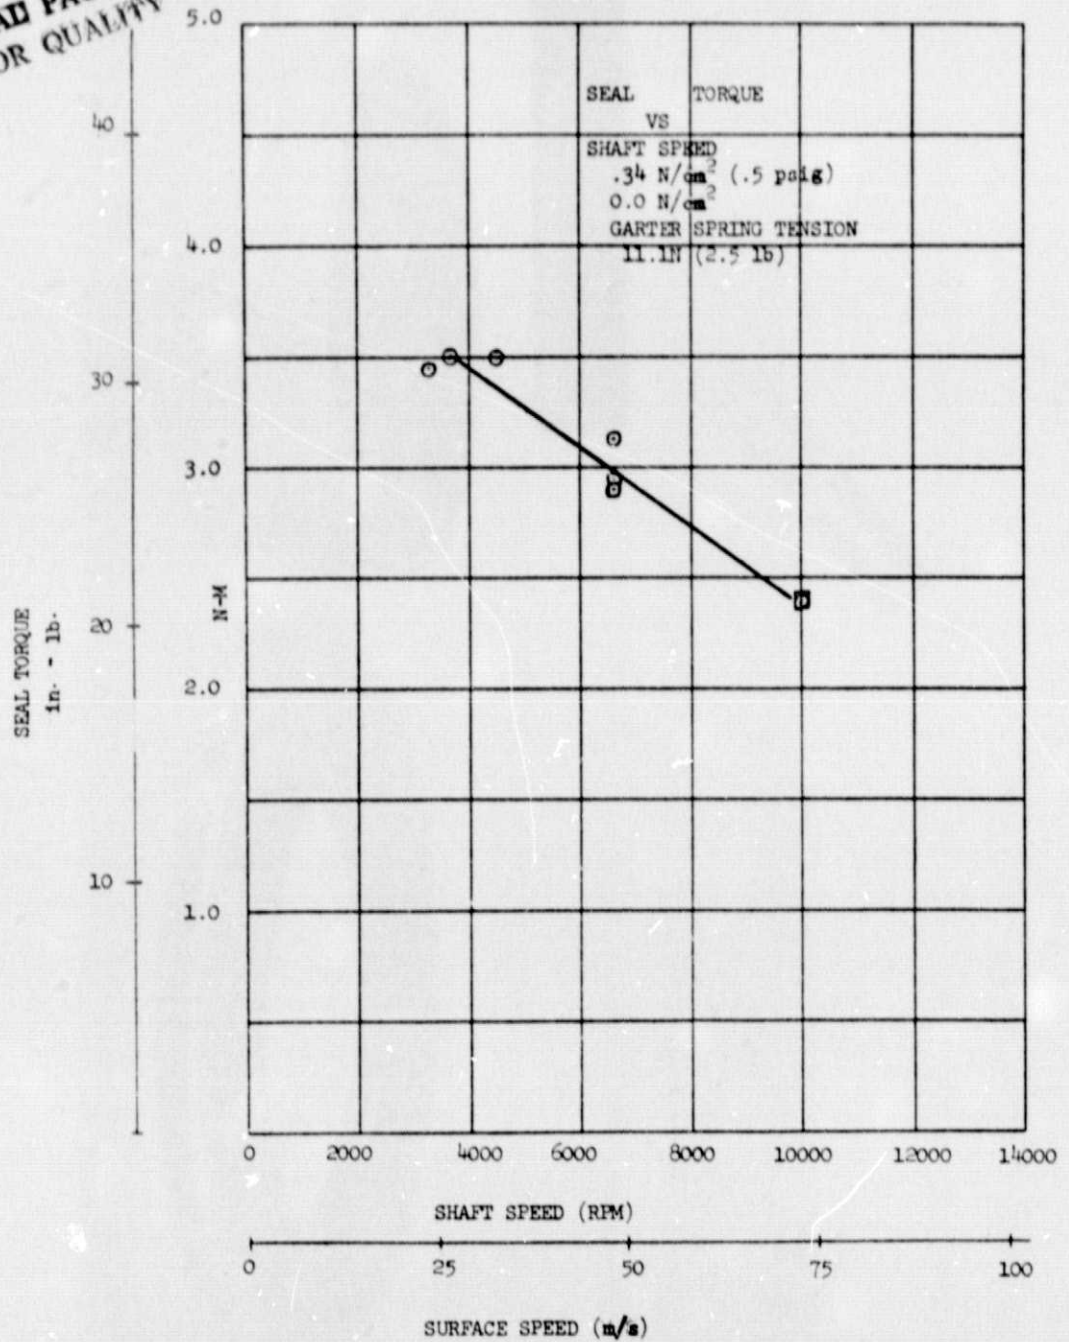
Figure 16. Seal Torque Versus Speed.

Seal torque measured over the test speed range is presented in Figure 16. As can be seen, seal torque decreases with speed and varies insignificantly with changes in bearing cavity pressure between 0.0 and .34 N/cm² (.5 psig). This concluded the planned 65 hours of testing.

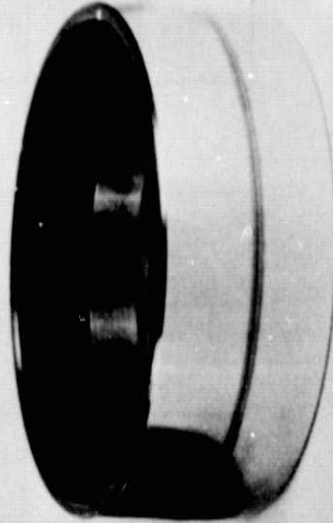
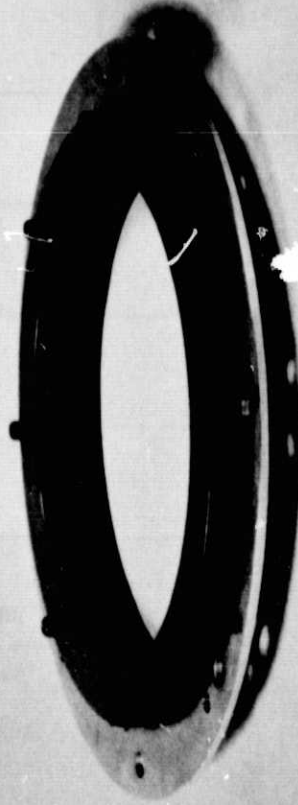
Figure 17. Seal and Runner After Test.

The seal was removed from the test rig, and photographs were taken of the seal components. Figure 17 illustrates the seal and runner at the completion of testing. A close-up of the seal runner and the contact area can be seen in Figure 18. An axial trace of the outside diameter of the seal runner shown in Figure 19 illustrates the depth of the worn area. Maximum wear of the carbon rings was observed at .00025 cm (.0010 in). A close-up of the seal bore in Figure 20 illustrates a contact (burnishing) on the air side sealing element extending for approximately 60 percent of the ring width. The oil side sealing element exhibits only very slight contact at the edge adjacent to the air side sealing element.

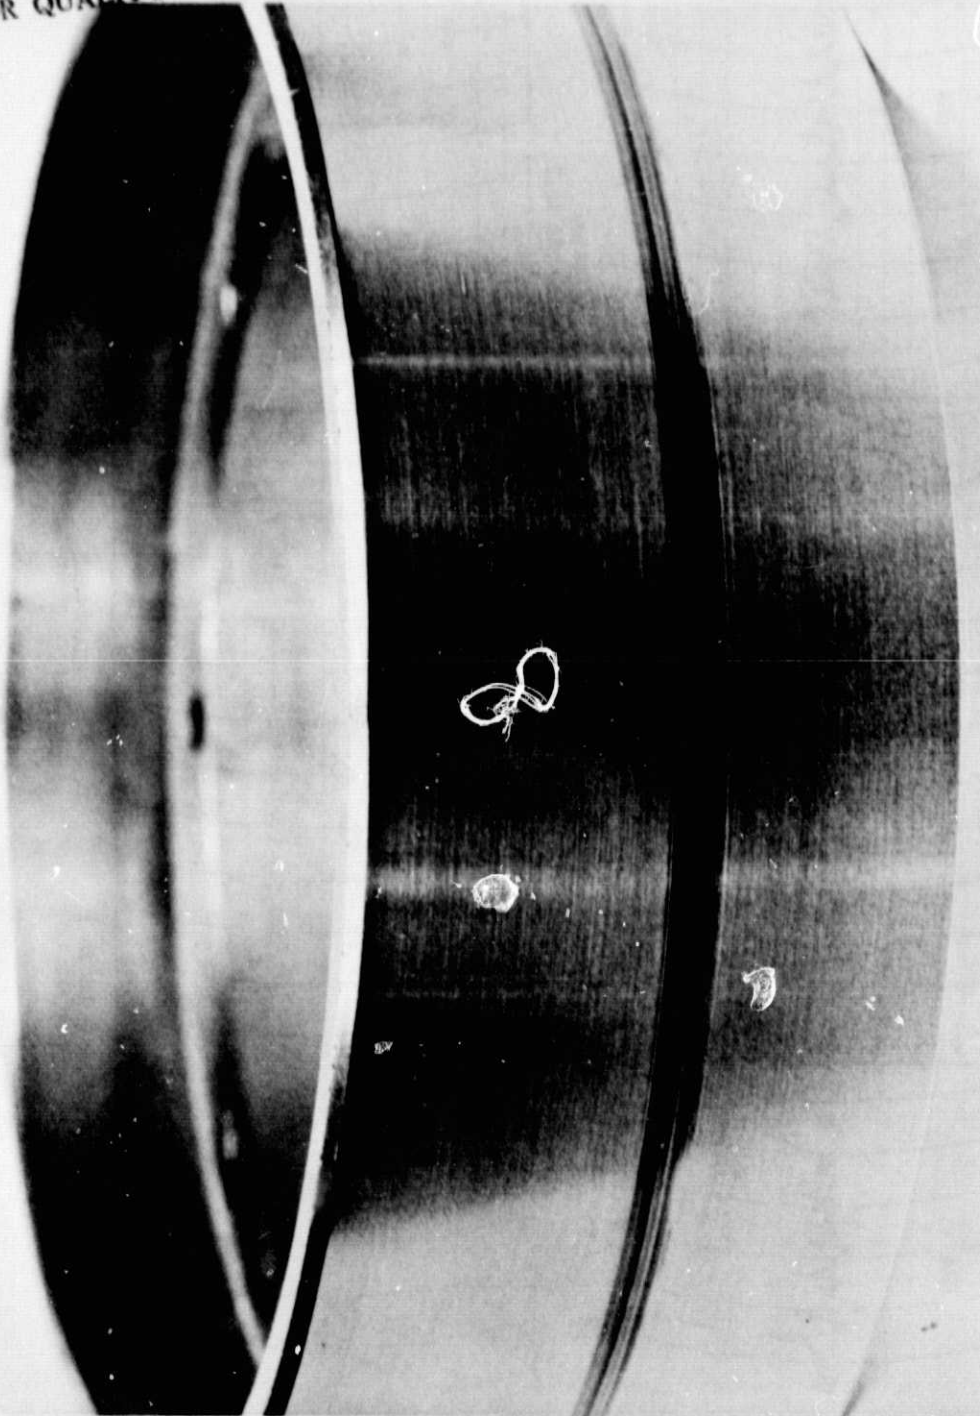
Figure 18. Seal Runner After Test.

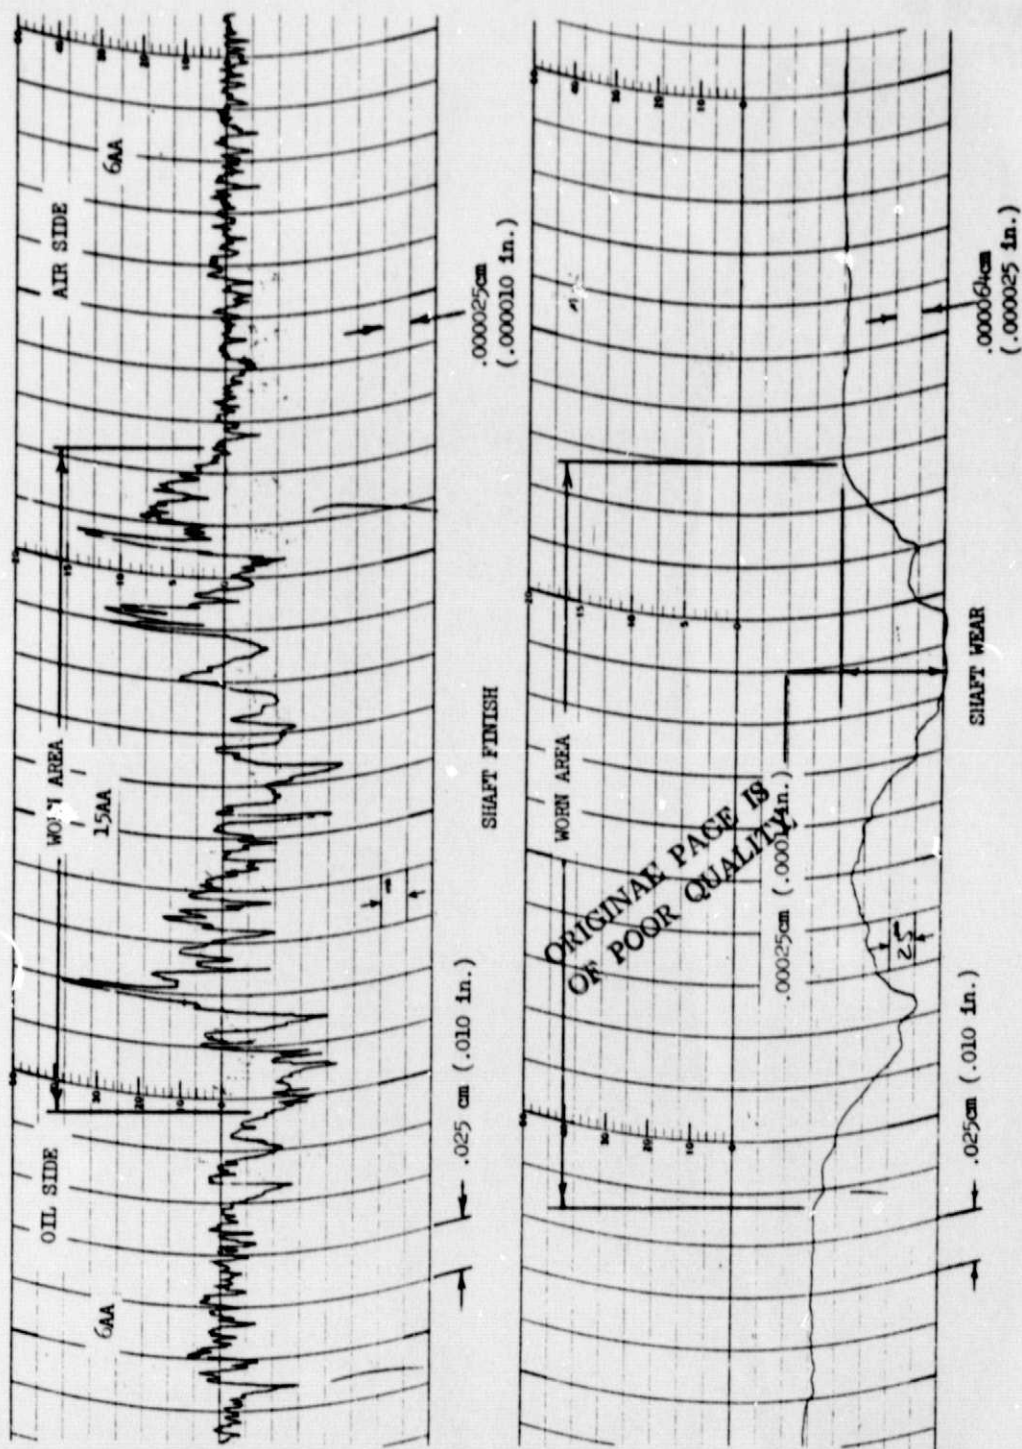
Figure 19. Seal Runner Finish and Wear After Test.
